# **DISRUPTIVE TECHNOLOGY IN THE ELECTRIC POWER MARKET**

**PIONEER TECHNOLOGY SOLUTIONS, INC**

**AUGUST 15, 2018**

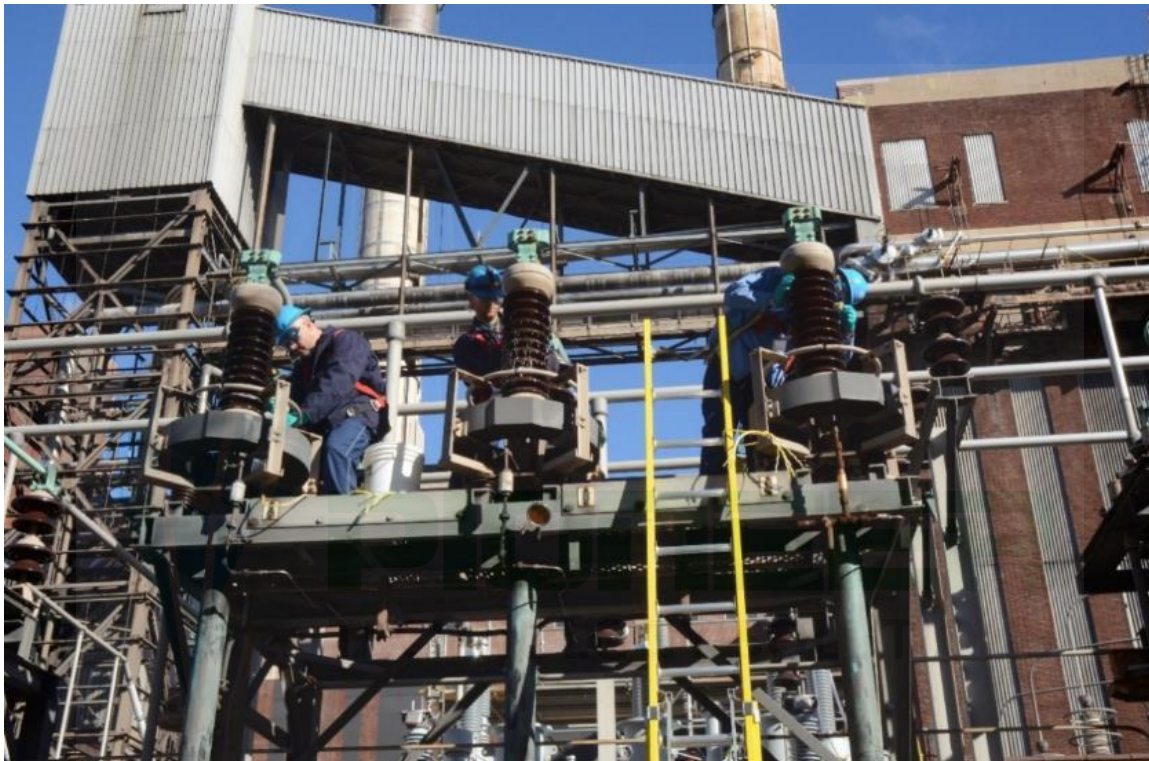
**Personnel cleaning and applying coating to bushings–November 16<sup>th</sup>, 2015**

Some key takeaways from applying the coatings were to thoroughly clean the porcelain cable terminations prior to applying the coating. This is the most important step of the coating process. Proper cleaning of the surface will ensure the best performance of coating. All cleaning and application of the coating was performed by hand.

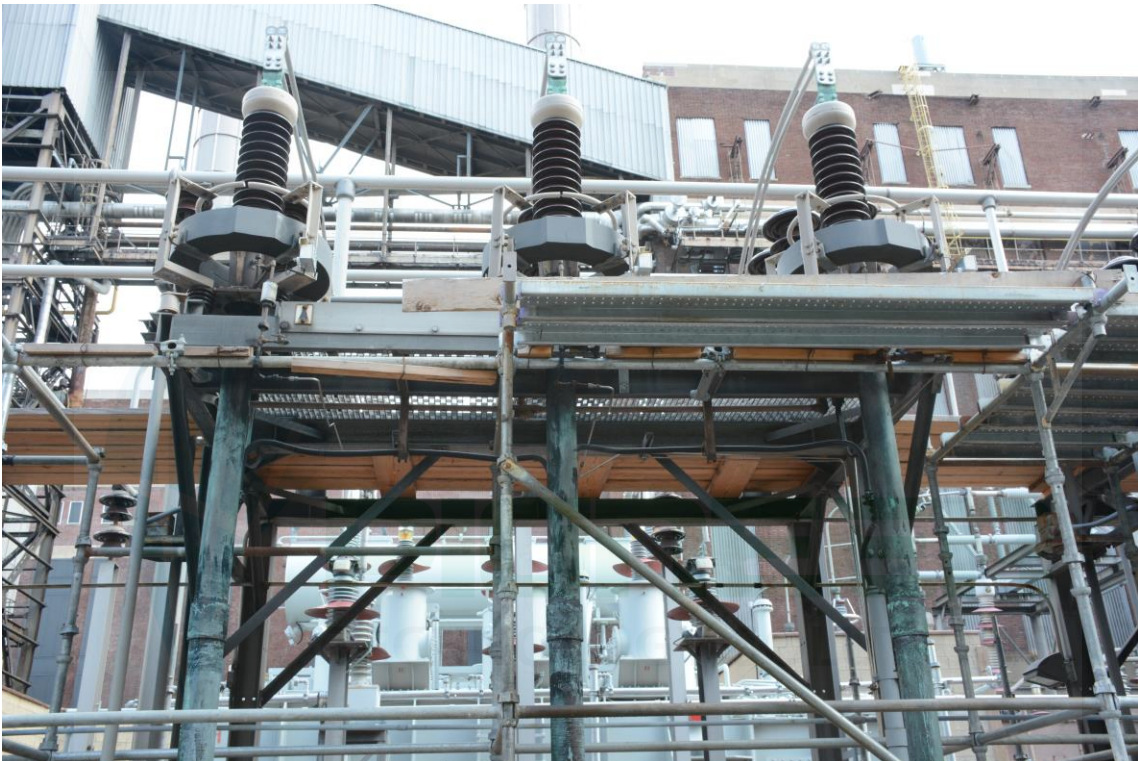
**August 22, 2018 - 32 months in service**

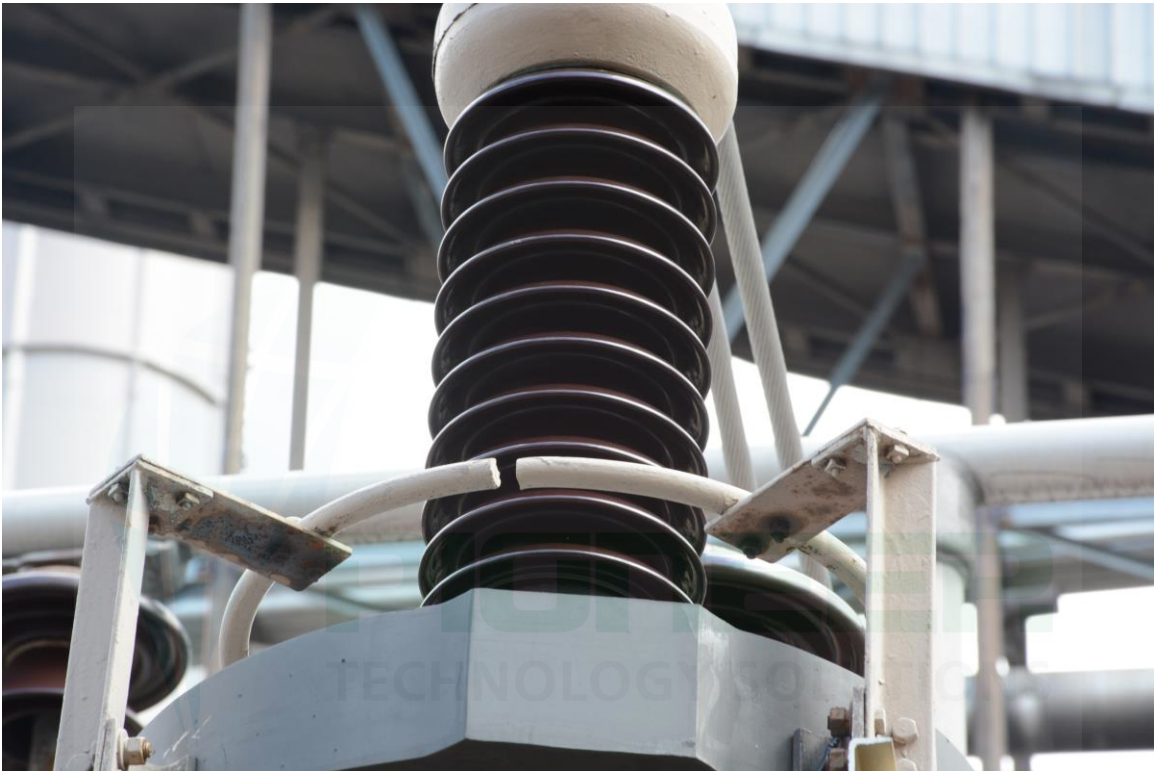
**August 22, 2018 - 32 months in service – closeup**

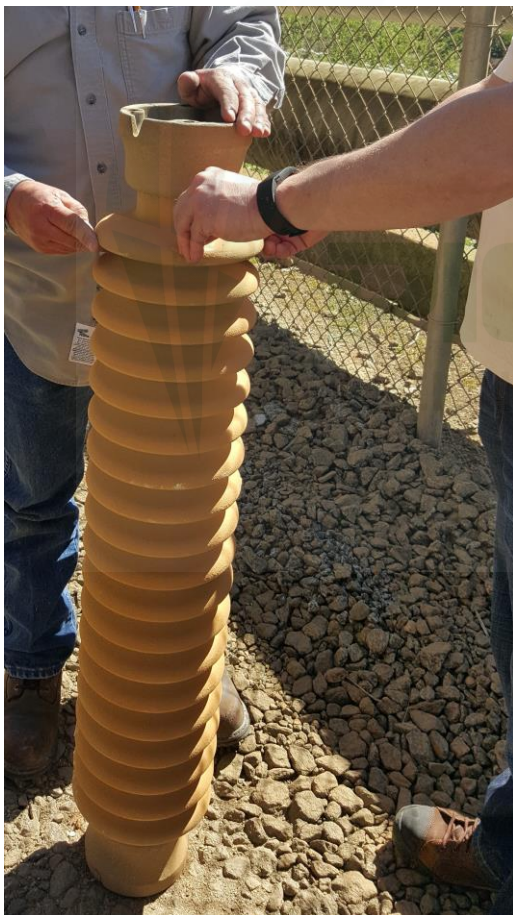
**Contaminated insulator replaced with a 'new' one on April 28<sup>th</sup> 2016.**

The substation has been experiencing a number of outages due to contamination problems. The sources of the contamination are the local cooling towers which are located where the prevailing winds carry the steam discharge across the substation causing self-contamination.

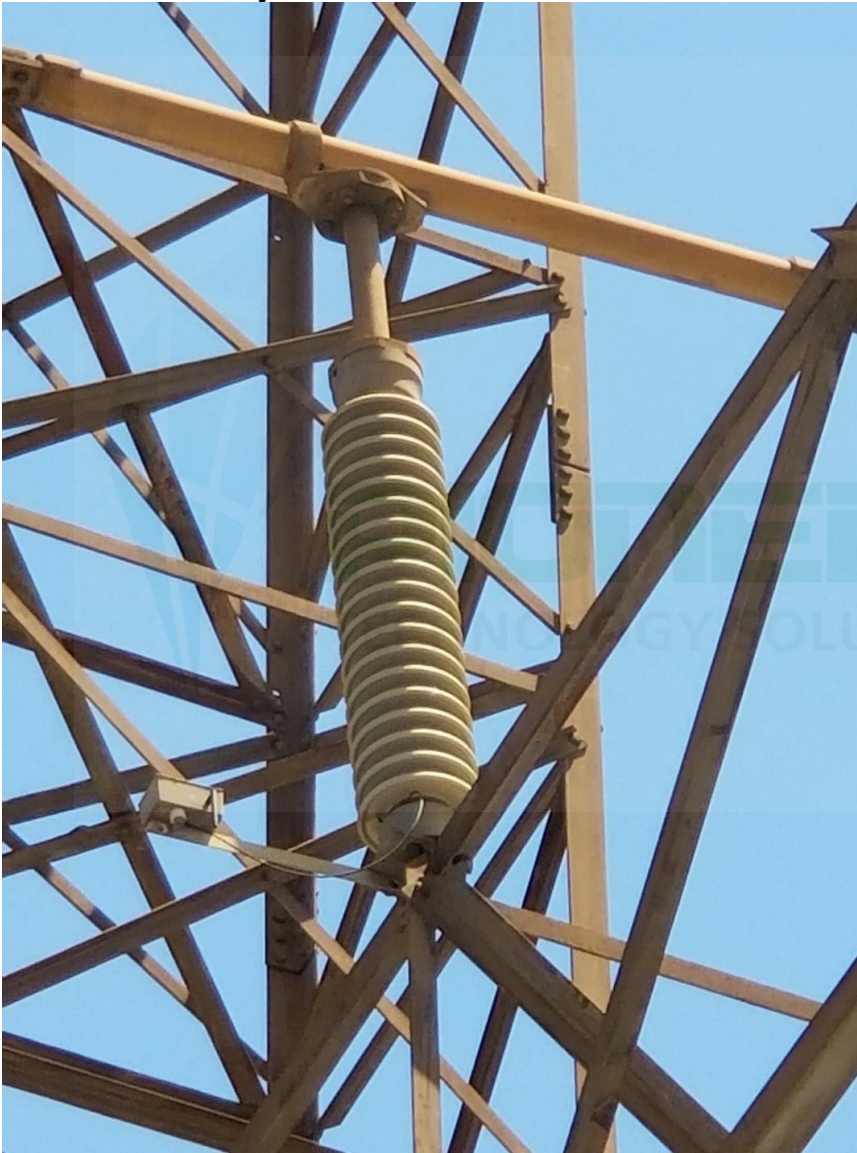
**Picture taken May 2<sup>nd</sup> 2018**

24 months after installation, the coated insulators that were installed have shown little contamination build up.

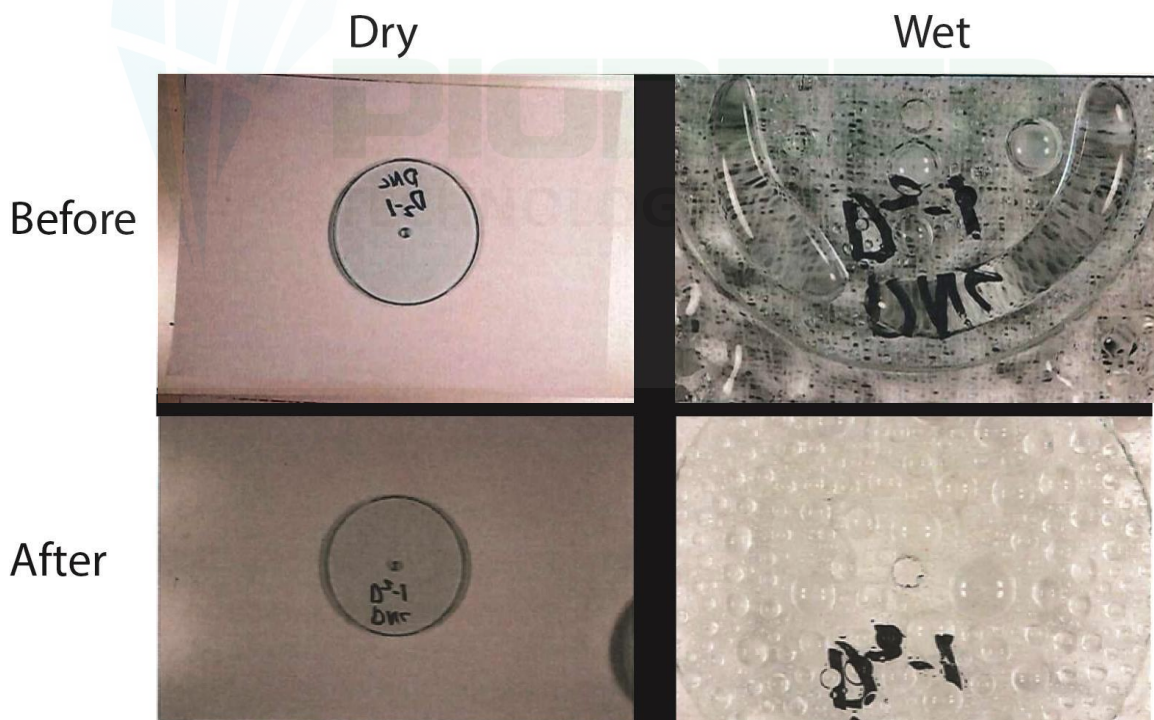
This picture captures the results of the 'Thermal' test ANSI C29.11 (mod.). It was performed on glass that had been used for a Taber® Abrasion test and as a result some of the substrate was removed. As you can see the 'Hydrophobicity' recovered after the Thermal test!

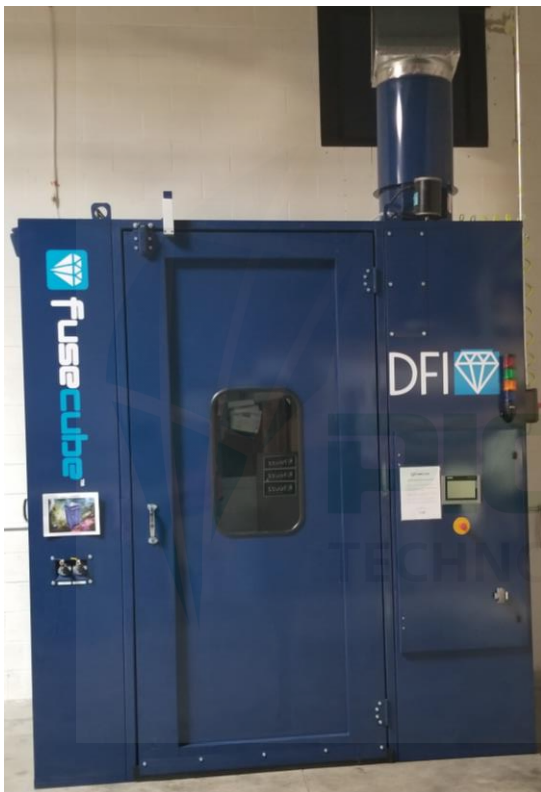
We have a machine that can **efficiently coat the insulators in a factory setting** and be ready for shipping within an hour.
